REMAINING WORKING RELIABILITY OF VERTICAL FIRED HEATER WITH SIMULTANEOUSLY USED RBI MATRIX

Abstract: *This paper deals with the reliability of a vertical gas heater installed in an oil and gas plant, which has been in continuous operation for an extended period. It provides a classification of fired heaters based on their construction characteristics, and outlines their role within the gas rectification process, including the types of equipment involved. The general construction of the heater is described, along with key design and operational process parameters. The paper also identifies damage mechanisms that affect this type of equipment. A Risk-Based Inspection (RBI) analysis was conducted, and an RBI matrix was developed, indicating that the equipment falls into the high-risk category in terms of both financial consequences and environmental impact.*

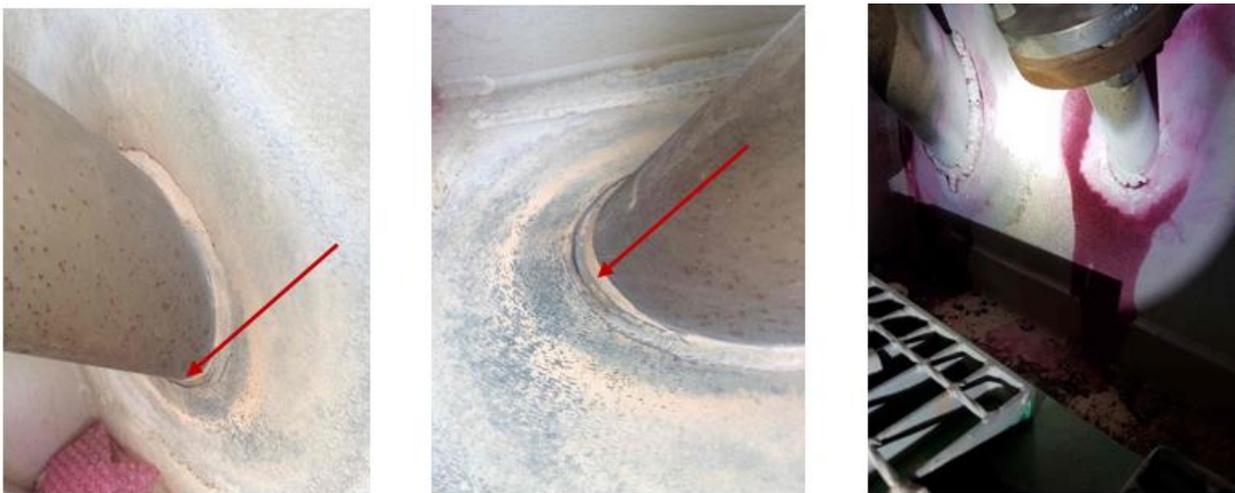
and their comparing with previously mentioned documentation and information related to the properties of the materials from which this equipment has been built and all in the goal of establishing relevant damage mechanisms, which can be expected (observed) during performing inspection activities. During performing external inspection of the equipment, it was observed circular weld cracks at the both thermocouple nozzles at the connection of thermocouple nozzle and shell of the heater and further analysis it has shown that these were cracks are consequence different material which are connected by welding. Namely thermocouple nozzles are made from stainless steel while the shell of the material is made from carbon steel and due long time working on higher temperature due different coefficient of thermal expansion of these material circular cracks were formed. Also, in sense of providing, more information regarding dimensions of the cracks penetrant tests were conducted which had shown their exact dimensions. After that, it was performed detail cleaning of damaged weld metal up to the sound metal by grinding process. For needs of remediation, mentioned weld defects it was used approved WPS and supported by appropriate PQR. Hence, because base metal of equipment shell is carbon steel and thermocouple nozzle were made from stainless steel for repairing activities it was used electrode E309L-16 with diameter 2.60 mm. For needs avoid possible hydrogen cracks after welding process electrodes were exposed to drying process on temperature 350 °C in duration of 1hour. On that occasion, it was used currency of direct polarity with the next parameters: Amperage range 90-110 A, voltage range 20-24 V. Travel speed range during performing repairing activities was in the range 68 mm/min. After finishing repairing activities detail visual inspection of repaired weld joints were performed while taking into consideration that weld joints, which are connecting dissimilar materials, are prone to delayed cracking, penetrant tests were performed 24 hours after finishing repair welding activities in sense of finding potential delayed cracks (Figure 6 and Figure 7).

Figure 6. Visually observed cracks at thermocouple nozzles and penetrant tests after repairing

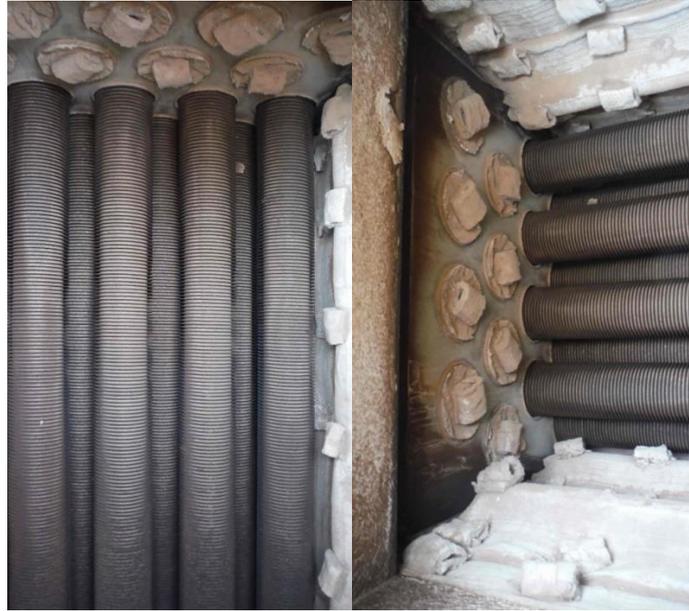
Figure 7. Finned tubes in convection zone of fired heater

As can be seen from the Figure 7 all finned tubes have found in good condition in time of examination and fins have found in straight positions also places which have planned for the future tubes installation were found properly plugged.

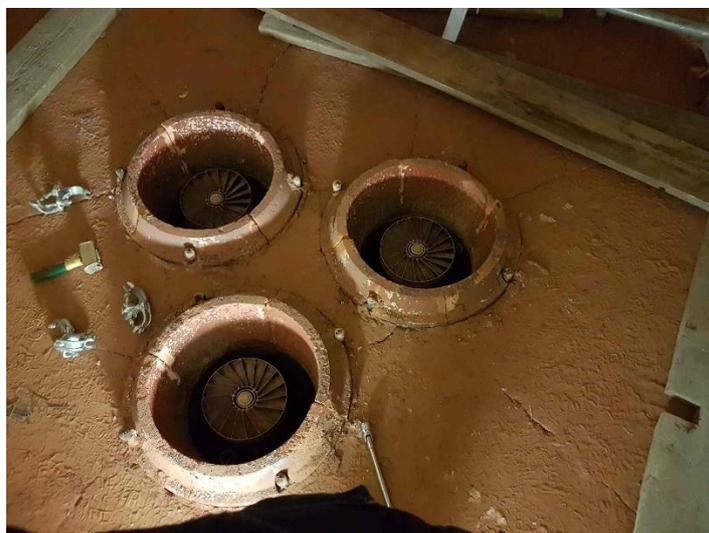
Within of internal examination it was performed detail visual inspection of the main internal elements, such as: refractory, cylindrical burners, which have installed in triangle schedule in the refractory, holes in the refractory which has function of moveable tube support, vertical tubes and appropriate tube fittings installed in the radiation zone of heater, thermoskin couples, available tubes in package of horizontal tubes which have installed in convection zone of the apparatus, fixed tube supports, bolts, nuts, etc... On that occasion, refractory (on the bottom) around burners has found damaged (with some cracks in refractory material) on some places but still in satisfactory condition and its repairing or changing will be conducted within the next planned shutdown (Figure 8).

Figure 8. Refractory and burners of fired heater

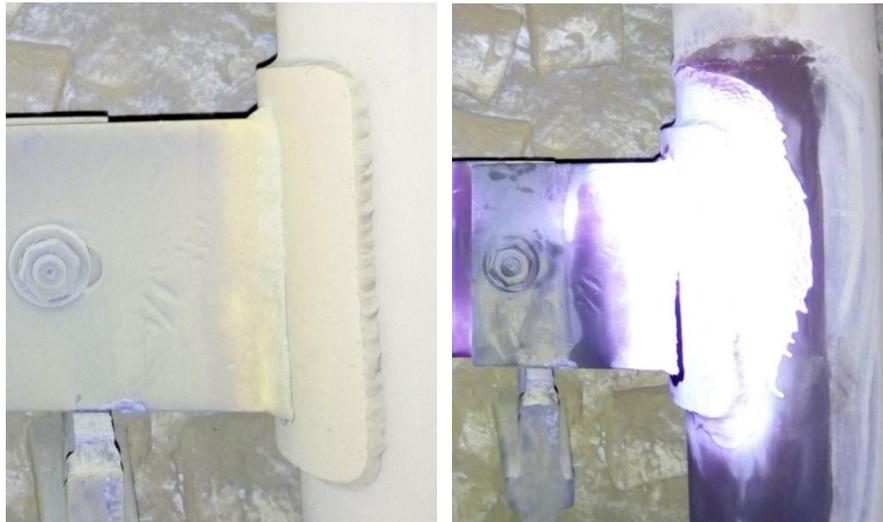
During visual examination of fixed supports for vertical tubes, longitudinal crack has observed. Existing of crack was also confirmed with penetrant test of this area.

Figure 9. Crack was observed at fixed support for vertical tubes and confirmed with dye penetrants

After that crack was successfully removed by grinding and tube-support was repaired by welding. Repaired weld joint was tested with penetrant test and it has shown that reparation was conducted in successful manner.

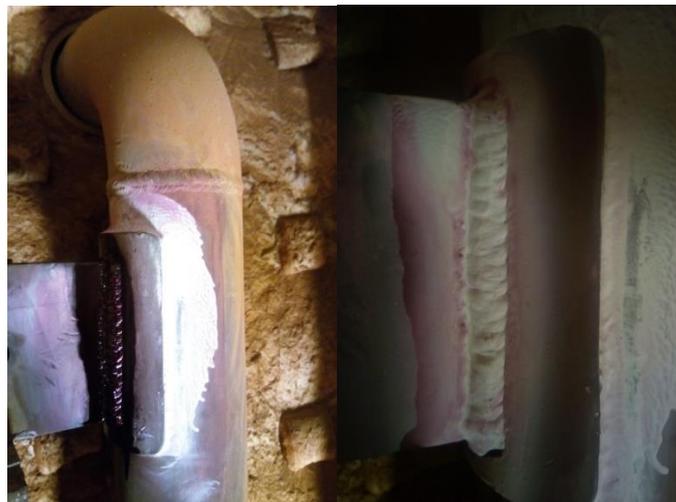
Figure 10. Repairing of the cracked support has performed in successful manner

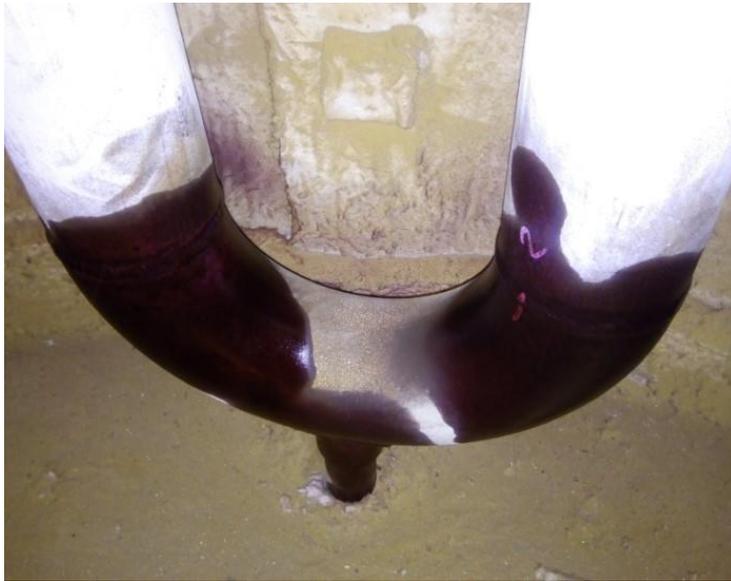
Together with inspection of fixed tube supports of the vertical tubes, detail visual inspection of down moveable tubes supports were performed. On that occasion, also, it was conducted measured of minimum free dilatation lengths and they were compared with maximum dilatation for this material (Figure 11).

Figure 11. Visual inspection of the moveable tubes supports at entering tube part in refractory hole

$l_{min}=100$ mm, in general case Δl should be $<l_{min}$, $52.49 \text{ mm} < 100 \text{ mm}$ so this condition is fulfilled.

This part of inspection also included checking of moving down part of tubes in the holes in the refractory in sense of checking possibilities of dilatation of the vertical tubes during operation period and avoiding distorting and cracking these tubes. Here should be highlight that at some tubes have observed difficult moving of down part of the vertical tubes (R-104-positions) due accumulation sand and dust in the refractory holes.

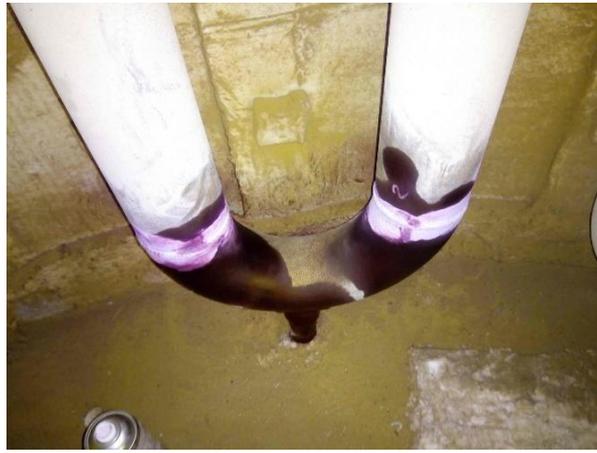
Penetrant test of the weld joints at connection of vertical tubes with elbows also performed and cracks have not observed in time of examination (Figure 14).

Figure 14. Penetrant tests of the weld joints of the vertical tubes in radiation zone

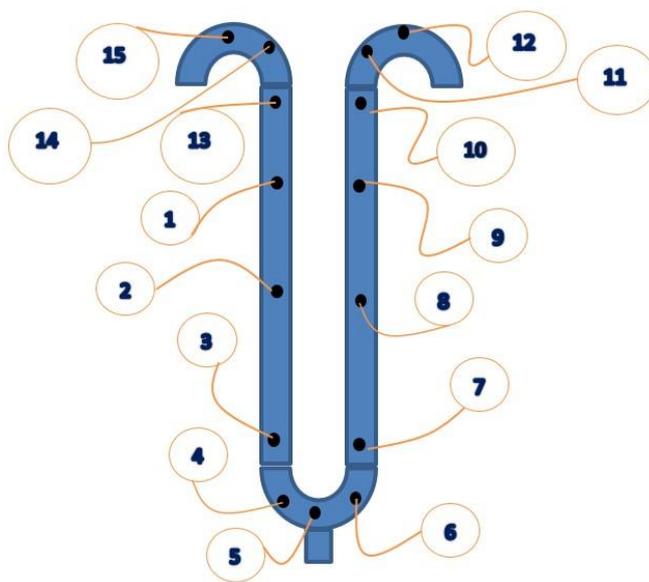
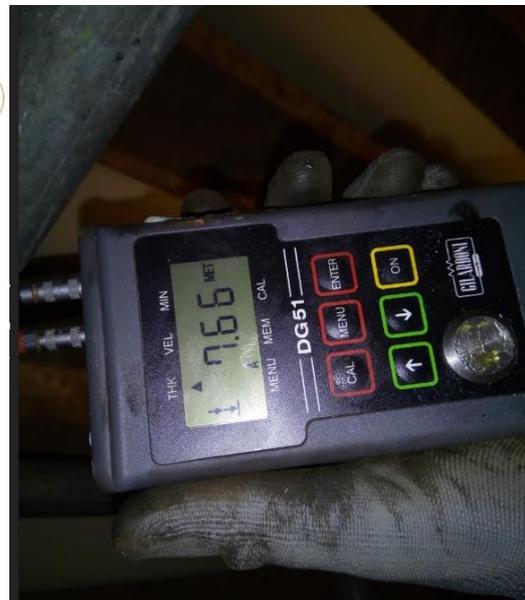
Further examination of apparatus status has included of performing ultrasonic thickness measuring of the vertical tubes in the radiation zone for needs of evaluation remaining life of apparatus. Scheme of ut-measuring has shown on the Figure 15 while review of the measured values has presented in the table 3.

Figure 15. Scheme of ut measuring at vertical tubes installed in radiation zone of apparatus

Calculated corrosion rate (long time) for the vertical tube (tube marked with 11 and position marked with 1 according to the Figure 13) will be:

$$CR(LT) = \frac{8.56 - 7.0}{13.50} = 0.1156 \text{ mm/year} \quad (6)$$

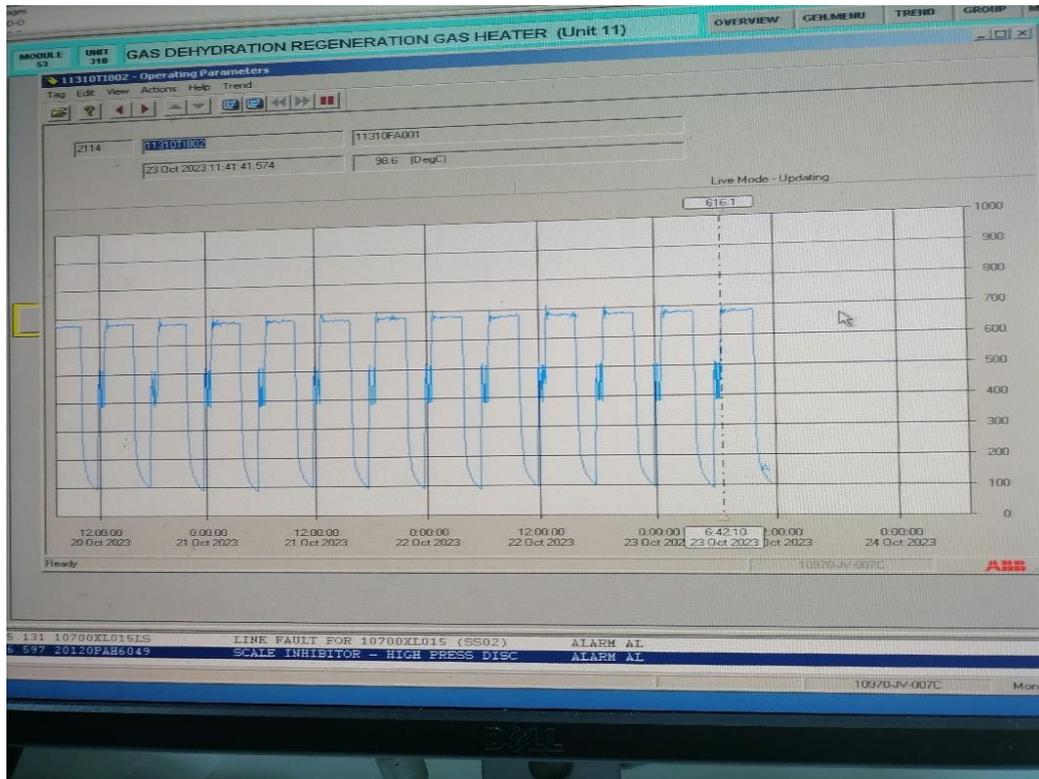
Figure 16. Values of temperatures on the vertical tubes in radiation zone

As can be seen from the Figure 16 values of temperatures in some moments have reached temperature around 700°C according from it can be concluded that vertical tubes have operated in deep creeping regime. Taking into account this fact maximum free dilatation for the vertical tubes will be: $L=9080$ mm, Material-CS-ASTM-A106 Grade, $T=700^{\circ}\text{C}$, $A = 18.0 \cdot 10^{-6}$ mm/mm/°C

According to this it can be concluded that low distortion of the tubes have started. Observed temperature (that is their amplitudes) are consequence of uneven work (and non settings) of the bottom burners. Like this type of behaviour of flames on the vertical tubes in some cases producing distortion of tubes and in the borderline case even a cracking of the tubes due even thermal expansion of side of the tube, which has directly exposed to the flame, and the other side of the tube. During performed visual examination of this fired heater, this effect luckily has not observed. Together with this and based on the information regarding of number of working hours can be concluded that metallographic examination should be performed after next 15000 working hours.

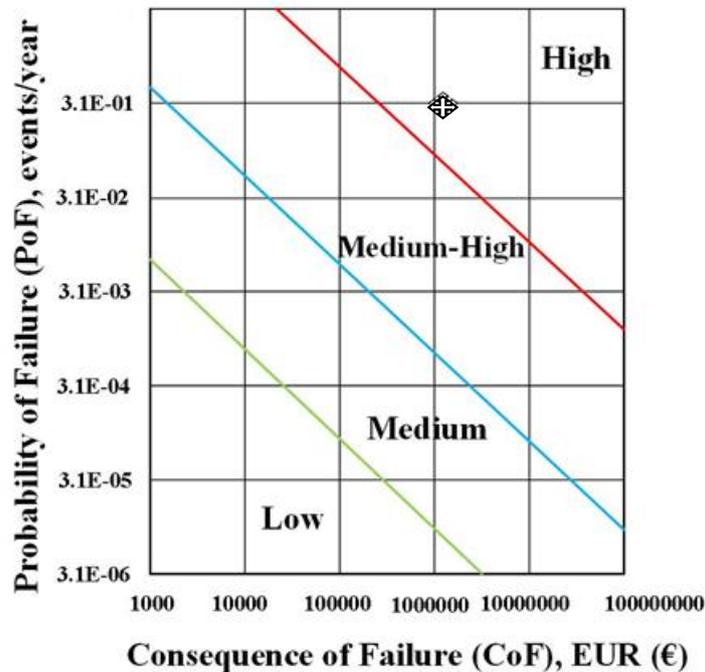
Based on obtained values, the calculated risk is $R= 1495062$. The results have been presented in the ISO-risk plot for the consequence of failure in Figure 17.

Figure 17. Iso-risk Plot for Financial Consequence

According to the previously mentioned calculation and according to the diagram will be concluded that examined vertical fired heater belongs to high level risk.
