## THE IMPACT OF CLERESTORY LIGHTS ON ENERGY EFFICIENCY OF BUILDINGS

Original scientific paper

DOI: 10.2298/TSCI131004187D

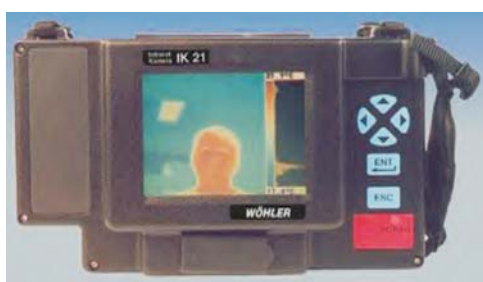
Figure 4. Woehler thermal imager IK21

Thermal imager used was a Woehler IK 21 (fig. 4) produced by Woehler GmbH, whose work is based on uncooled linear thermoelectric germanium detector [6]. It forms a thermal image by measuring the infrared radiation of the whole body or of a particular scene. The use of software which the camera possesses the necessary correction were made in converting thermal images into the corresponding thermogram, which is approximately accurate temperature of the recorded object or temperature distribution of the object in the scene. Also, the camera runs on standard batteries for video cameras. Moreover, the images are displayed on a color LCD screen with 10.2 cm long diagonal. The digital infrared thermal imager is based on patent camera with thermal-electronic effects, and it covers the range from  $-20^{\circ}\text{C}$  to  $3500^{\circ}\text{C}$ , with thermal sensitivity of less than  $0.1^{\circ}\text{C}$ . Measurement accuracy is between  $-2^{\circ}\text{C}$  to  $+2^{\circ}\text{C}$ . Detector type is FPA  $320 \times 240$ , with the wave lengths in the range from  $3.6\text{ }\mu\text{m}$  to  $5\text{ }\mu\text{m}$ , using a set of batteries of 4 metal hybrid batteries, and with working temperature from  $-15^{\circ}\text{C}$  to  $50^{\circ}\text{C}$ . The mass of the camera is 2 kg, while the dimensions are  $220 \times 132 \times 140\text{ mm}$ . Figure 4 shows the thermal imager Woehler IK 21 which was used [6].
