INFLUENCE OF RUNNING CONDITIONS ON RESONANT OSCILLATIONS IN FRESH-AIR VENTILATOR BLADES USED IN THERMAL POWER PLANTS

Original scientific paper

High frequency cyclic load of fresh air supply to ventilator blades in thermo energetic facilities can cause the occurrence of fretting in the pressed overlap of ventilator shaft and socket. These loads can be generated by the resonant oscillations of ventilator blades and thermal residual stress due to welding. To prevent running in resonant conditions, the manufacturer of the ventilator defined a procedure of adjusting blades natural frequency in the process of production, as well as period control during exploitation period. The numerical simulations and the accelerations measured and presented in this paper, enabling analysis of mass changes and rotation rate effects on resonant oscillations occurrence in fresh air ventilator.

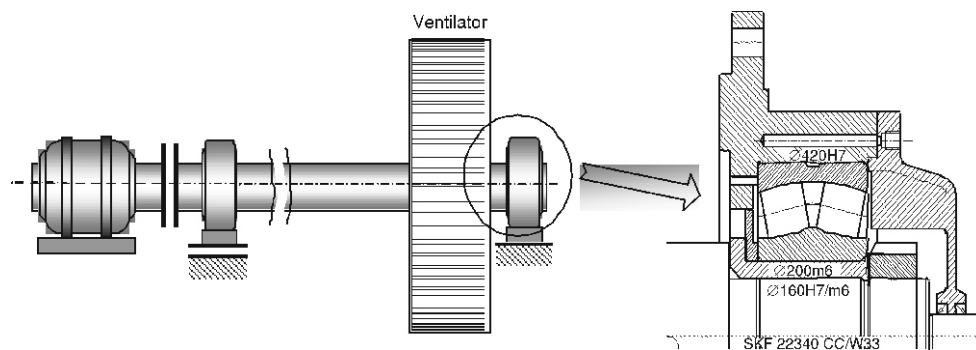
Figure 1. Cross-sections of the bearing bedding SKF 22340 CC/W33

As the consequence of inappropriate running conditions, failure of internal bedding may occur. In the worst case, bearing blockage leads to overheating of the assembly, collapse of the material mechanical characteristics and excessive shaft journal bending [1]. This leads to the bending which exceeds the allowed limit, causing contact between ventilator blades and case. Collision between blades and case causes damage of ventilator assembly parts. The process occurs at very high speed, so the existing temperature supervision systems are unable to detect the damage, leading to melting of the inner bearing ring, socket, and shaft journal. Cross-sections of the bedding are shown in fig. 1.

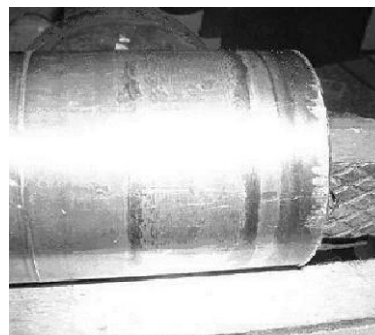
Figure 2. Damaged journal surface caused by fretting

When two pieces of material, pressed together by an external static load (for example, press fits or bolted flanges) are subjected to transverse cyclic loading, so that one contacting face is relatively displaced, parallel to the other face in the presence of high contact stress, wear on the mating surfaces occurs. If the displacement magnitude is less than about 50 μm , the wear is termed “fretting”, fig. 2.

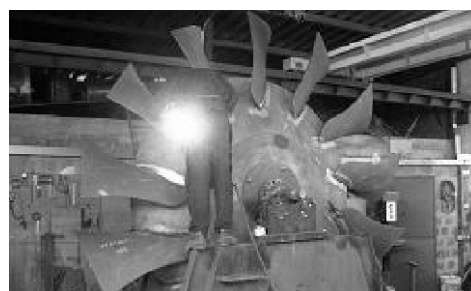
Figure 3. Ventilator production – welding of blades

Blades are placed into proper position and partially welded by a special tool. In the end, complete welding of blades root is performed on the rotary positioning device, used for the purpose of putting the ventilator into optimal welding position, fig. 3. This process can also put some allowed errors in real shape of the ventilator. That geometry imperfections cause unbalanced centrifugal forces and different natural frequencies of the body segments and all blades.

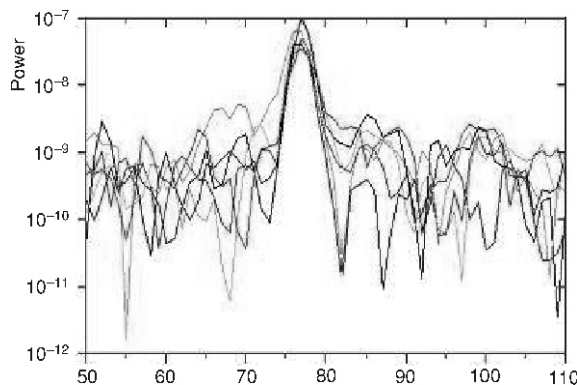
Figure 4. Area of the first natural-frequency mode

The processed signal from several measurements, with isolated area of the first natural-value of the oscillation, is presented in fig. 4.

The diagram shows six consecutive measurements. Peak of the measured parameter in all cases matches the natural frequency of 78 Hz. The amplitudes are uneven on the left and right sides due to uneven hammer hits, which caused the measured oscillation.

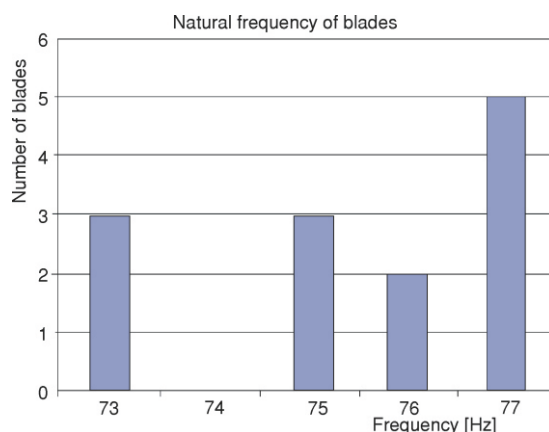
Figure 5. Measured values of blade's natural-frequencies

Figure 5 shows several ventilator blades with the same natural-frequency values. The measurements were done on one of the produced primary stage air ventilators.

The ventilator has 13 blades. Three of them have natural frequency of 73 Hz, other three 75 Hz, two 76 Hz, and five 77 Hz. This points out the importance that the final product – ventilator with controlled dynamic characteristics – can not be produces just according to technical drawings, prescribed welding technology and thermal treatment, but that it is essential to adjust the blades dynamical characteristics experimentally, adding or removing mass on top of the blades.

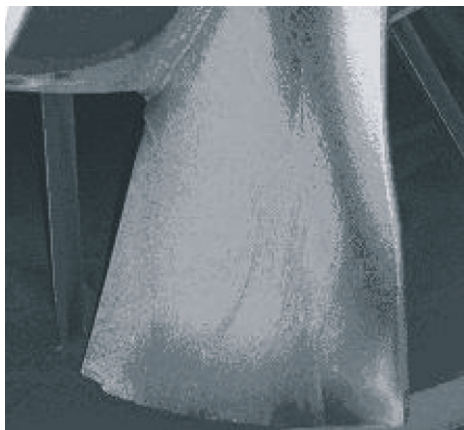
Figure 6. Damaged blade zones

It is possible to perceive that the blade edge is damaged, especially on the top of aero profile front edge. The rear edge is missing a piece of the material.

During the exploitation time, erosion of the blades takes place, especially in the area with highest drift speed. Abrasion is performed by dust and sand, fig. 6.

Mass decrease on blade edges leads to increase of natural-frequency, so even already adjusted blade gets into the situation that its natural-frequency can match some harmonics of the ventilator electro-motor basic speed revolutions.

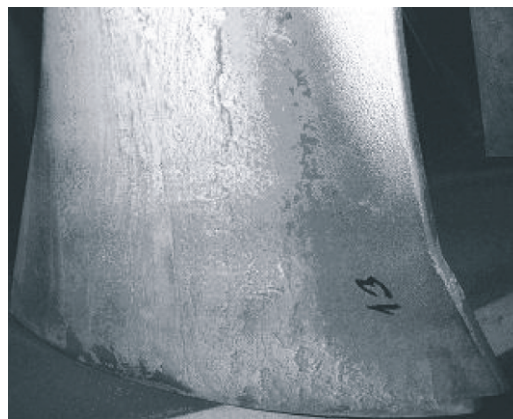
Figure 7. Blade surface with attached layer of dirt

Figure 7 shows appearance of the blade on the surface of which a layer of dirt is attached, increasing the mass and decreasing its natural frequency.

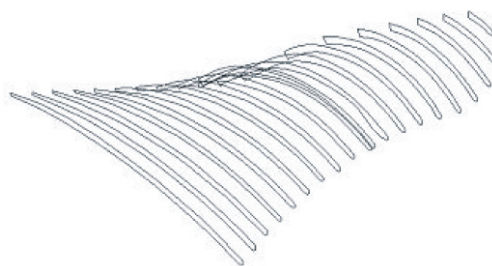
Figure 8. Blade cross-sections

This study pays special attention to journal and socket slipping caused by fretting. It examines the likelihood of periodic axial loads in journal socket assembly, caused by ventilator blades resonant oscillations. The finite element software, modal analysis package, was used for simulation of the 3-D blade models dynamic behavior. The numeric machine for 3-D measuring, located in the production facility of “21 May” company, was used to define the 3-D blade model. Original blade, manufactured by the “TLT” company from Germany, was used as a sample. Using the 3-D scanner, the coordinates of blade cross-sections were registered at each 20 mm, fig. 8. Based on these data, the blade profile cross-sections were defined. With the 3-D modeling software, these cross-sections were connected into one 3-D blade body. Ventilator body was modeled using the standard 2-D documentation and drawings.

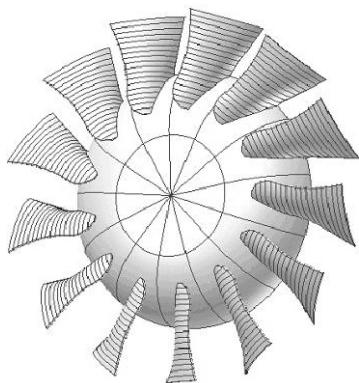
Figure 9. 3-D CAD model of the W33 air ventilator

The 3-D model of the ventilator, fig. 9, was imported into finite elements method (FEM) software for the calculation of natural frequency and natural mode shape oscillations.

Change in mass results in change in natural frequency. The blade with reduced mass has natural frequency increased to 52.2 Hz. The models for which mass was added on the top (example is the triangle shaped top in fig. 9) resulted in the decrease of natural frequency value. Accord-

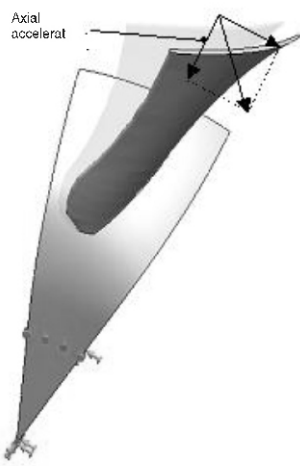
Figure 11. Natural frequency of standard blades – 51.4 Hz

As an example, cases of a standard blade are shown, fig. 11, and of a blade with reduced mass achieved by cutting off the top, fig. 12. In both cases, the basic shape of oscillation is the one which bends the blade in its root, at the area where it is constrained by ventilator body. The figures depict the starting position (shaded) and final position of the blade. The standard blade's natural frequency was 51.4 Hz.

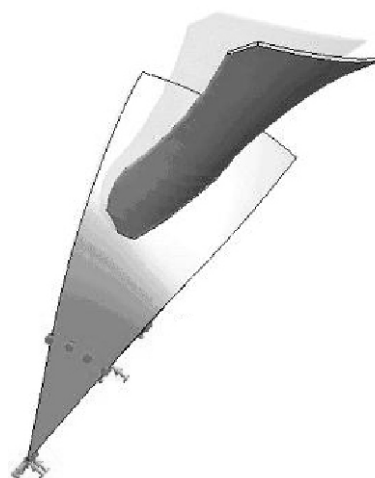
Figure 12. Blades frequency with reduced mass – 52.2 Hz

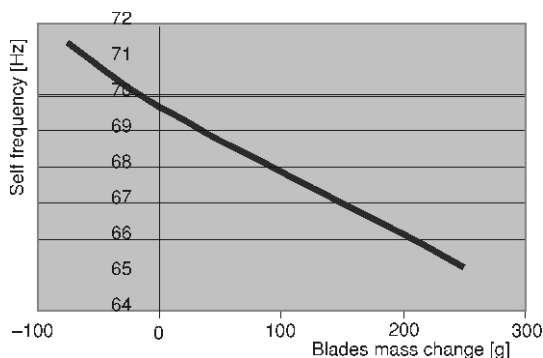
ing to the results [2], it is possible to define sensitivity of natural frequency change to mass change of the blade's top. This change is shown in fig. 13. It can be perceived that a relatively small mass change (ca. 200 g) of the blade, which has 50 kg in total mass (0.4%), changes the natural frequency by ca. 6%.

Figure 13. Influence of blades top mass change on its natural frequency

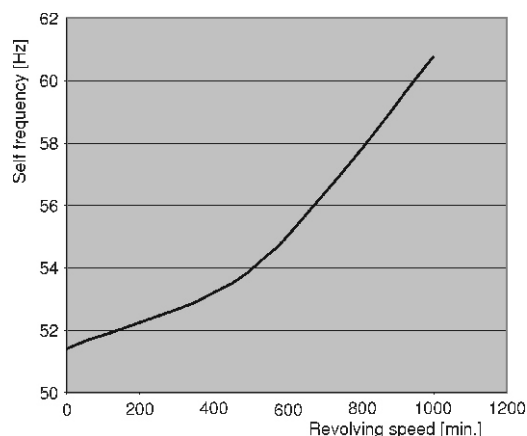
Strains increase in the direction of the blades top. Rotation simulations were performed to estimate this influence, with different revolving speed, starting from 0, 450, 740 up to 1000 per minute. Results are shown in the diagram on the fig. 14.

It is visible that the change in revolving speed has smaller influence on ventilator's natural frequency than the mass change. Change of the revolving speed by 21%, changes the natural frequency by 2 Hz (3.5%).

Figure 14. Influence of revolving speed
