## STUDY ON IMPACT PROPERTIES OF CREEP-RESISTANT STEEL THERMALLY SIMULATED HEAT AFFECTED ZONE

Original scientific paper

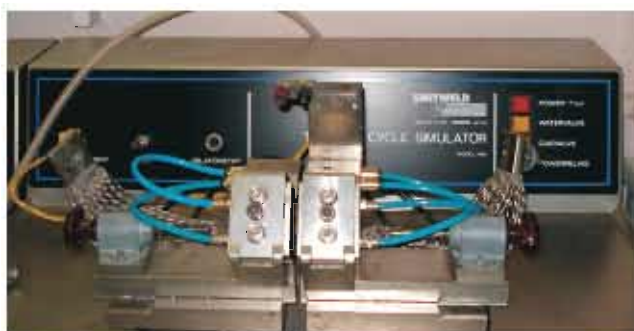
Figure 1. Heat affected zone simulator SMITWELD

Today, welding simulators are used to determine mechanical properties of the “weakest link” *i. e.* critical microstructure within a HAZ. Welding simulator (fig. 1) is a device that achieves controlled heating and cooling similar to the thermal cycle during welding. The difference is in obtained micro structure, on a sample size of  $10 \times 10 \times 60$  mm, and at its middle part, as microstructure which corresponds to the desired critical area. The critical area of HAZ is usually coarse grain zone, and simulation enables the exact identification of fundamental mechanical properties [14, 15]. Input parameters are performed via computer, and selection of the basic parameters can be determined from the calculation of the temperature field or by the using of appropriate equations to calculate  $\Delta t_{8/5}$  in the welding thermal cycle [16]. The origin of the parameters can be also experimental obtained, by measuring the thermal cycle with the thermocouples.

Simulation of steel 12H1MF samples was performed on the simulator Smitweld LS1402, on the Welding Institute in Timisoara, Romania. A simulation of thermal cycles and thermal treatment was carried out for all these combinations of specimen groups, NP-L, NP-T, OP-L, and the OP-T:

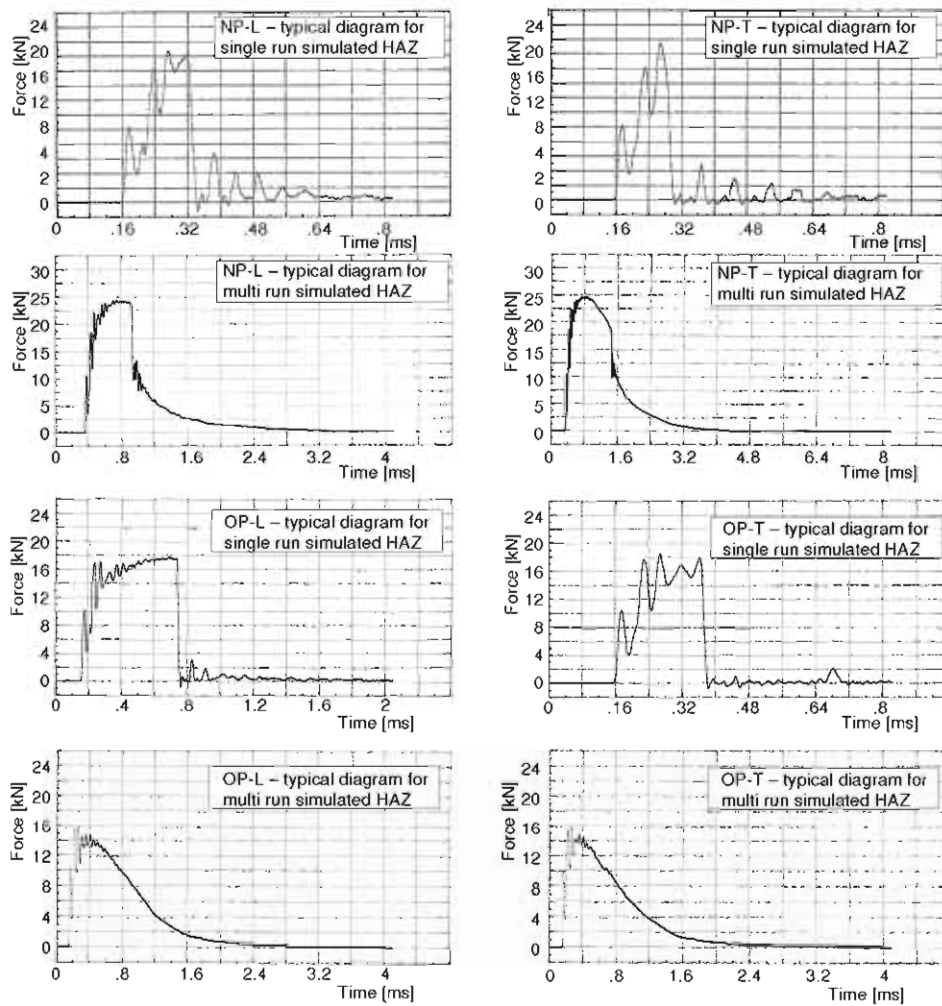
**Figure 4. The appearance of characteristic force-time diagram**

In fig. 4, the typical force-time diagrams of samples, are presented.

Examination of the impact energy was carried out on Charpy instrumented pendulum, with maximum impact energy of 300 J. That made possible to determine not only the total, but also initiation and propagation energy of the tested material. Test results are shown in tabs. 4-7.

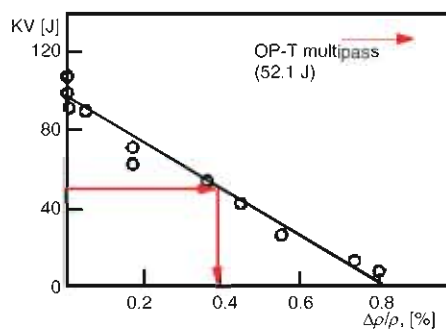
Figure 9. The change of the impact energy with an increased density of pores in 12H1MF

As expected, the lower values of impact energy with a simulated tube welding cycle are quantitatively verified, in accordance with a literature. It was determined that there is a linear dependence between density (*i. e.* number) of pores in materials, and the energy that is absorbed during impact testing. Based on the value of impact strength, it was possible to show in this way that it can not only strengthen the fact regarding formation of micro pores due to creep, but also
