## EXPERIMENTAL INVESTIGATION OF THERMAL BARRIER (8YSZ-TiO<sub>2</sub>-Al<sub>2</sub>O<sub>3</sub>) COATED PISTON USED IN DIRECT INJECTION COMPRESSION IGNITION ENGINE

Original scientific paper  
DOI: 10.2298/TSCI16S4189M

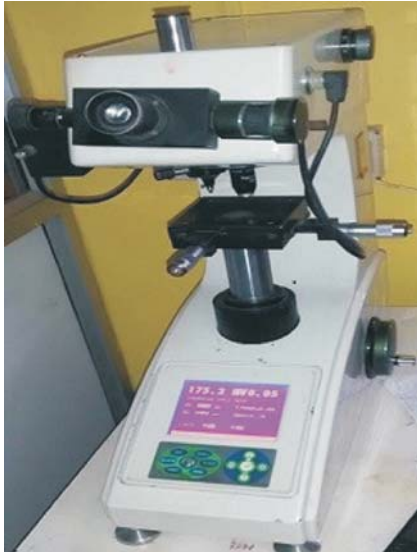
Vickers micro hardness tester is shown in fig. 1. The hardness values of the coated and uncoated samples were determined using a micro indenter (THV-1M, micro Vickers hardness tester) with a Vickers tip for a load of 3 N.

Figure 1. Vickers micro hardness tester

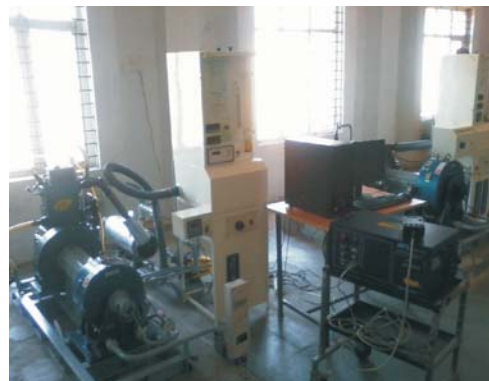
The pictorial view of the engine test set-up is shown in fig. 3. The single cylinder 4-strokes Diesel engine set-up was done and the specifications of engine were noted in tab. 2. The engine was run at constant rpm and the performance calculation has been done by using obtained readings. The performance of engine was compared with the standard readings of that engine by the piston before coating.

Figure 3. Pictorial view of engine test set-up

Calibrated burette is used for fuel intake measurement. Orifice meter fitted to the air inlet tank with water manometer for air intake measurement. Multi-channel digital temperature indicator used for measure the temperature at various points.
