REMAINING WORKING RELIABILITY OF VERTICAL FIRED HEATER WITH SIMULTANEOUSLY USED RBI MATRIX

Abstract: *This paper deals with the reliability of a vertical gas heater installed in an oil and gas plant, which has been in continuous operation for an extended period. It provides a classification of fired heaters based on their construction characteristics, and outlines their role within the gas rectification process, including the types of equipment involved. The general construction of the heater is described, along with key design and operational process parameters. The paper also identifies damage mechanisms that affect this type of equipment. A Risk-Based Inspection (RBI) analysis was conducted, and an RBI matrix was developed, indicating that the equipment falls into the high-risk category in terms of both financial consequences and environmental impact.*

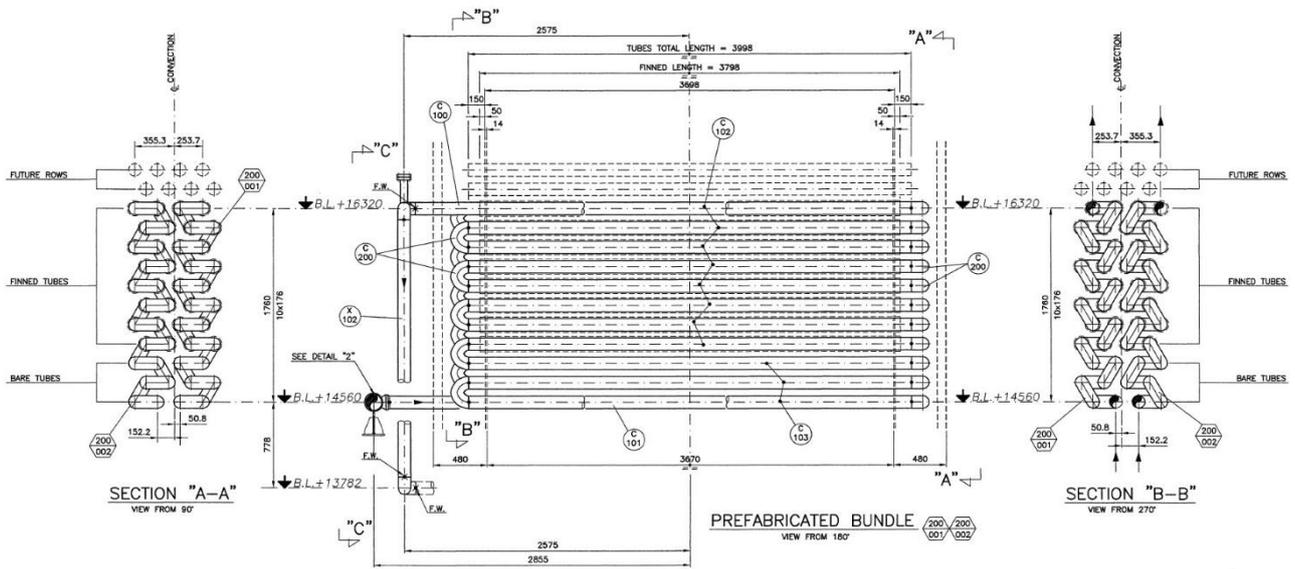
Figure 4. Package of horizontal tubes in the convection zones of the heater

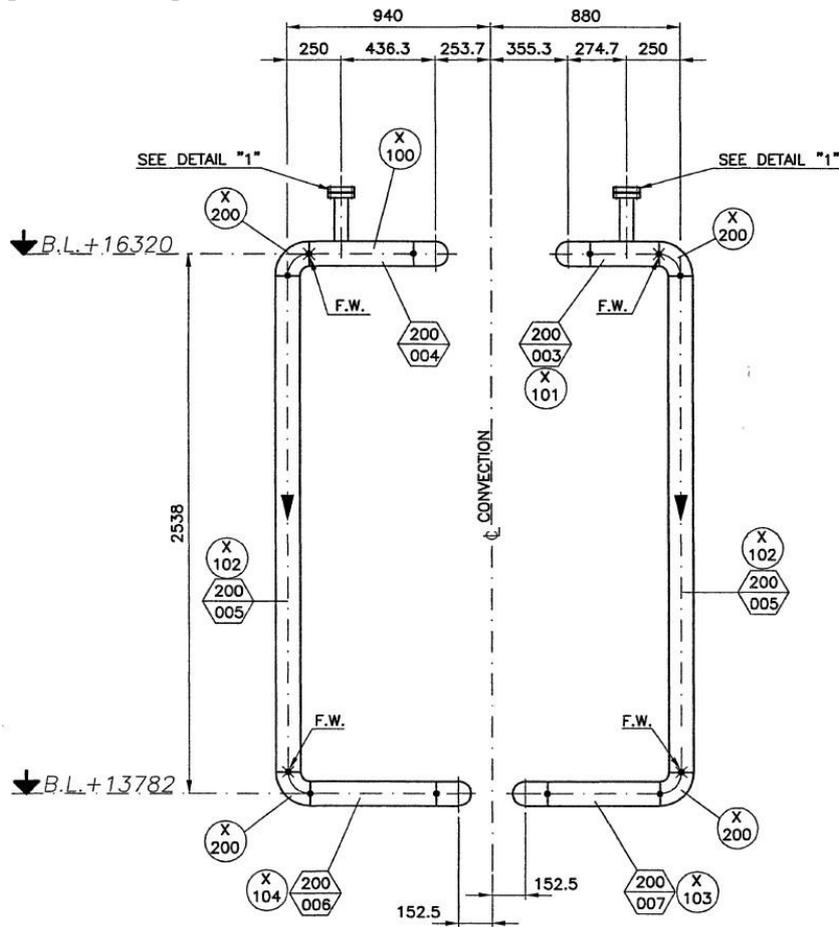
Figure 5. Package of horizontal tubes in the convection zones of the heater

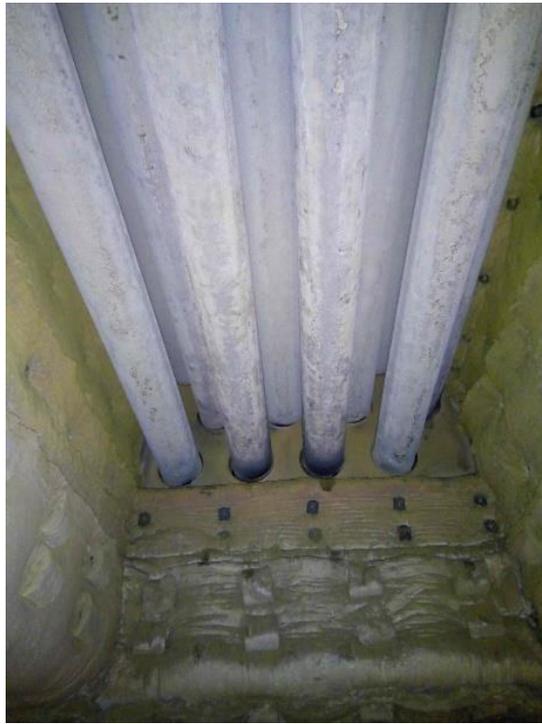
Inspection of internal tubes has included visual examination of available tubes installed in horizontal tube package in the convection zone and vertical tubes, which have installed in radiation zone of apparatus (Figure 12 and Figure 13).

Figure 12. View of horizontal tubes in the convection zone and vertical tubes in radiation zone

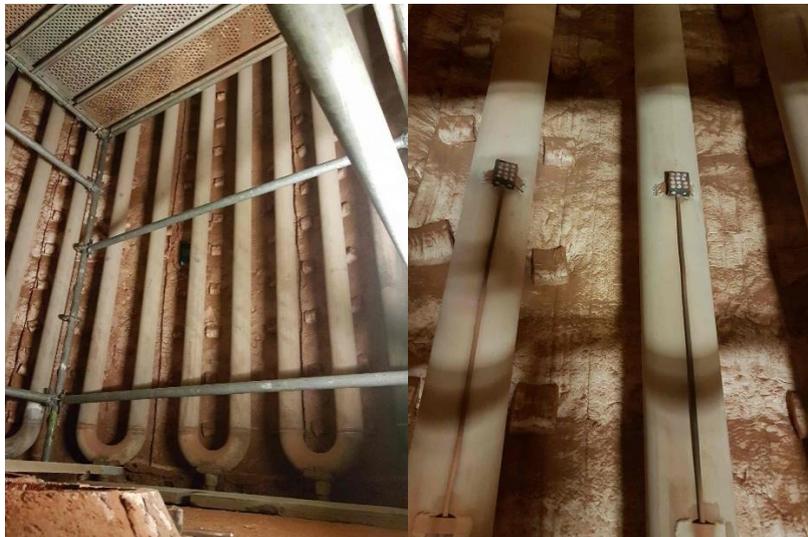
This part of inspection also included checking of moving down part of tubes in the holes in the refractory in sense of checking possibilities of dilatation of the vertical tubes during operation period and avoiding distorting and cracking these tubes. Here should be highlight that at some tubes have observed difficult moving of down part of the vertical tubes (R-104-positions) due accumulation sand and dust in the refractory holes.

Figure 13. View on the vertical tubes in the radiation zone in the apparatus
