# INVESTIGATE THE CORROSION PROPERTIES OF STELLITE COATED ON AZ91D ALLOY BY PLASMA SPRAY TECHNIQUE

Original scientific paper https://doi.org/10.2298/TSCI200722209K

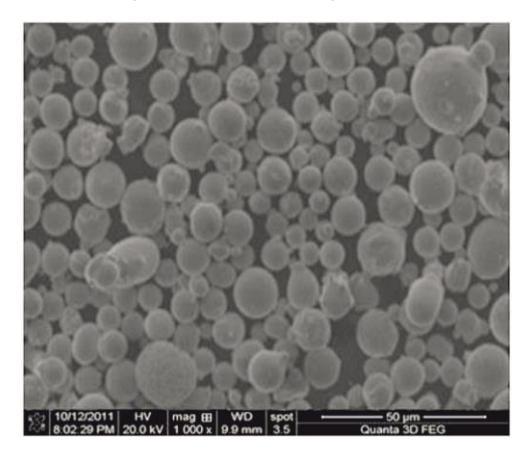
Figure 4. The SEM images of stellite powder

Figure 4 illustrates the SEM image of the pre-alloyed Stellite 6 superalloy powder used in the experiments. It was seen in the SEM images that Stellite 6 powders had a spherical form. The results of EDAX is shown in fig. 5, Ni has the maximum contribution at the range of 20 wt.%, fig. 5.

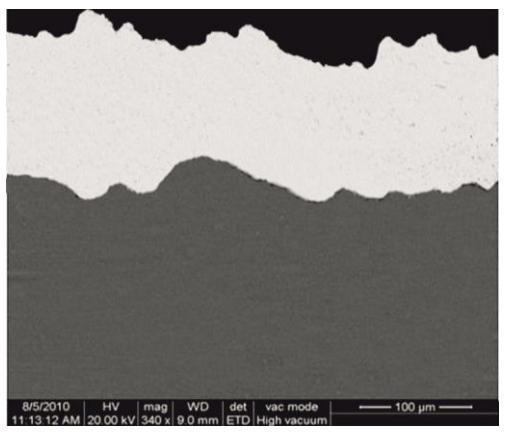
Figure 6. Micro-structure of the as-sprayed coatin

Figure 6 demonstrates the micro-structure of the as-sprayed coating. The coating is made of single splats. During the grit blasting process, the  $\alpha$ -Al<sub>2</sub>O<sub>3</sub> particles were periodically detected at the boundary between the coating and the substratum embedded in the substrate material.

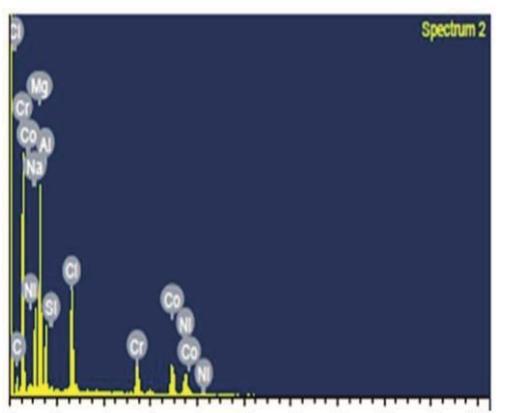
2 4 6 8 10 12 14 16 18 20 Figure 7. The EDS analysis of coating

Analysis of micro-structure and energy-dispersive X-ray spectroscopy patterns revealed that the stellite coating formed had a lamellar structure consisting of phases  $\alpha$ -Co and  $\ddot{y}$ -Co and carbides rich in chromium, fig. 7. The existence of two allotropic modifications of pure Co and its alloys (high temperature fcc phase and low temperature hcp phase) is described in the literature.

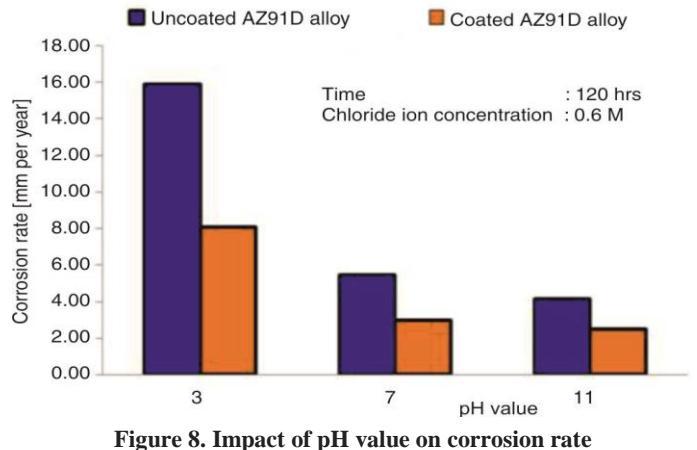
This study investigates the impact of pH level, chloride ion concentration, and the constant exposure time at 0.6 M, 120 hours, while the pH level was changed from 3-11. Figure 8 represented compare the impact of pH value on the corrosion rate.

The pH value has an inverse proportional relationship with the corrosion rate from the fundamentals; *i.e.* if the pH value increases, the corrosion rate decreases. The highest corrosion rate was observed at pH 3 and at neutral pH, the corrosion rate remained approximately constant and the alkaline solution showed a comparatively low corrosion rate. It is proposed that when compared with low concentration in neutral and alkaline solutions the pH effect in corrosion rate is high at higher concentration. Accordingly, corrosion domains of selective chromium leaching and dissolution of both iron and chromium can be found in the AZ91D magnesium alloy.

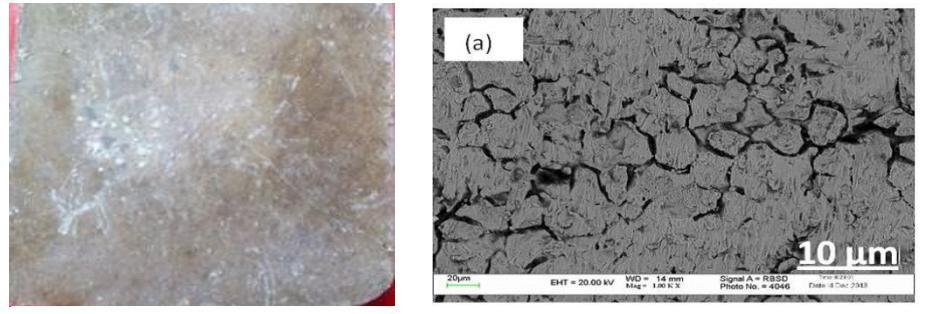
Figure 9 displays the SEM photos of the Mg alloy corroded uncoated and coated AZ91D immersed in NaCl solution. A brown Tarnish colour on the surface of the uncoated magnesium alloy AZ91D at a low pH value. This change in colour because of the advancement of the uniform dezincification and the sharp separation line between the dark side of the materials. In the presence of MgCl2 in the solution, the dezincification was happened, which could be proof of the conversion or dissolution of Mg+ into the electrolyte. These chloride layers are reason for destroying the Mg film, fig. 9(a), particu-

larly in acidic solutions, which lead to higher corrosion rates. Corrosion in stellite coatings occurs mainly by dissolving the Cr process and removing W particles in the matrix. Deletion of W particles in the matrix of the Fe-Cr

Figure 9(a). Uncoated AZ91D Mg alloy pH value = 3 Corrosion time = 120 hours Cl - concentration = 0.6 M

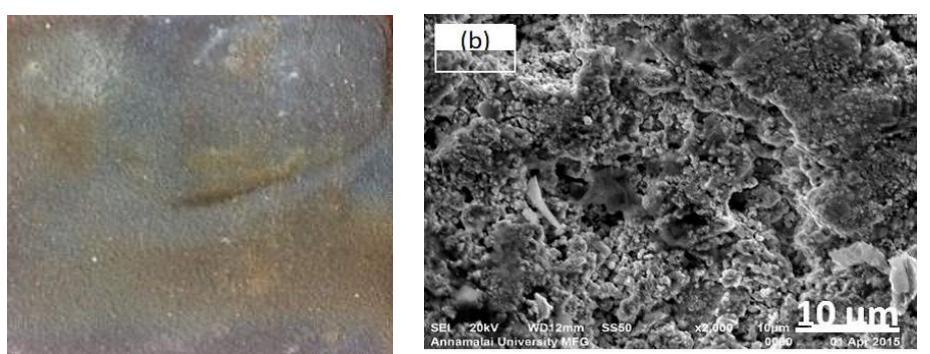
binder is shown in fig. 9(b). The presence of oxidizers at lower pH values increases the oxidation reactions in acidic solutions, resulting in a maximum corrosion rate. At the neutral pH level, the coating does not show true passivity, meaning in an entire matrix, corrosion film is not formed continuously. The Cr was eliminated from the Fe-Cr matrix, while chloride was exposed and form the  $Cr_2O_3$ . At a higher pH level, the proof of corrosion product formation is a high-density gold coloured layer formed over the surface of coated and uncoated and coated material surface, as shown in fig. 9(c). Iron and chromium appear to form the chloride layers while exposed to chloride ion conditions. Oxides of chromium and iron were gradually lost, and corrosion was observed.

Figure 9(b). Coated AZ91D Mg alloy pH value = 3 Corrosion time = 120 hours Cl - concentration = 0.6 M

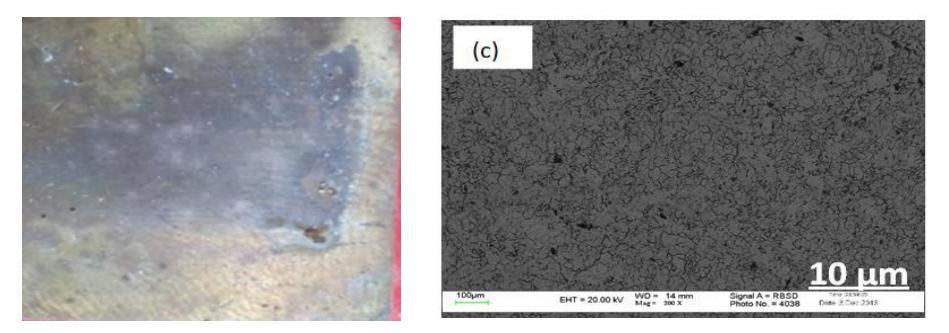
Figure 9(c). Uncoated AZ91D Mg alloy pH value = 11 Corrosion time = 120 hours Cl – concentration = 0.6 M

Stellite-coated AZ91D Mg alloy exposed to environmentally containing chloride, the deposits the chloride layer on the binding metals cannot kill the greater corrosion protection. The corrosion rate in magnesium alloy AZ91D coated thus shows low. In fig. 9(d), but some porosity and pits occurred because of these electrolytes, galvanic coupling between metals and corrosion is reported in the coating and forms. Study of atomic microscopy was performed on the top surface of the corroded specimens to understand the process of material removal from the surface. Figure 9(a) shows the pH-value impact of uncoated AZ91D Mg alloy on corroded surfaces. It is inferred from the picture that the Mg alloy AZ91D experiences higher material removal and can be visualised in the higher Ra shape, while fig. 9(b) the coated AZ91D Mg alloy has a lower surface roughness value relative to the bare substrate and its material loss. Although the depth of the pit is shallow in the coated surface, it also affects the area in the coating that is exposed to corrosion media. Low corrosion rate was observed at higher pH level, but the degree of undulation is minimal, figs. 9(c) and 9(d).

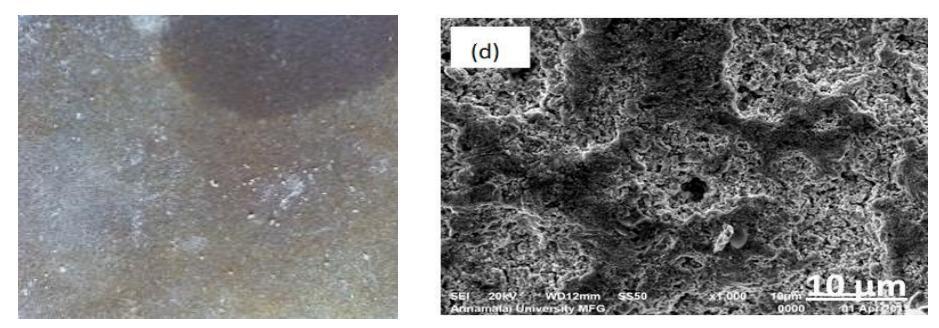
Figure 9(d). Coated AZ91D Mg alloy pH value = 11 Corrosion time = 120 hours Cl - concentration = 0.6 M

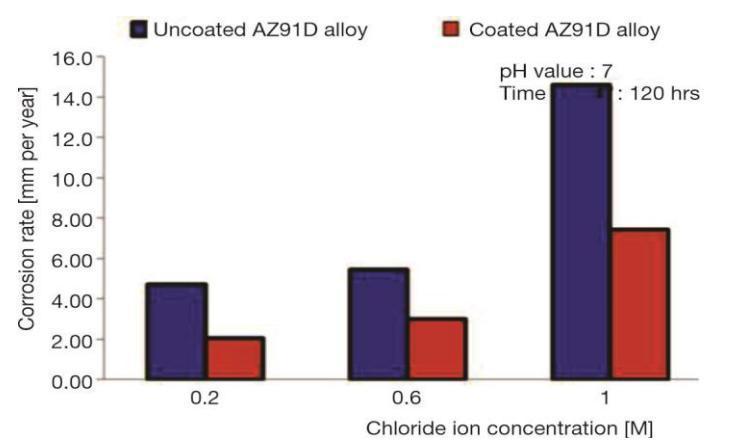
Figure 10. Impact of chloride ion concentration on corrosion rate

The influence of chloride ion concentration on the corrosion rate of uncoated and coated AZ91D Mg alloy in fig. 10. In the experimental process, the pH value was 7 Hr, and the exposure time is 120 hours, But the chloride ion was at a different level (0.2 to 1 M).

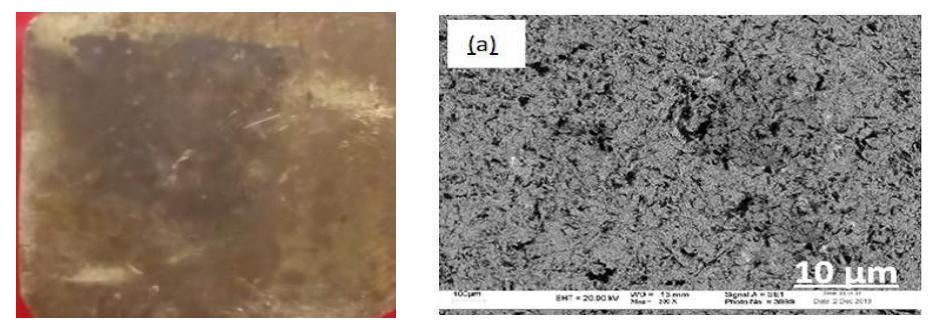
Figures 11(a)-11(d) represent the chloride iron concentration in various concentration levels like 0.2 and 1. The minimum amount of macropores be seen in fig. 11(a). The chloride ion-containing level is very high to the uncoated AZ91D, and small chloride ions are the reason for less effect over the region. Light brown color indicates the matrix corrosion shown in fig. 11(b). It seems obvious that the corrosion may occur in the thick hard phase matrix around the splat boundary, which is the reason for a macro trap. The pit appeared to by lower concentration of chloride ions. But the pit narrowed and became

Figure 11(a). Uncoated AZ91D Mg alloy pH value = 7 Corrosion time = 48 hours Cl - concentration = 0.2 M

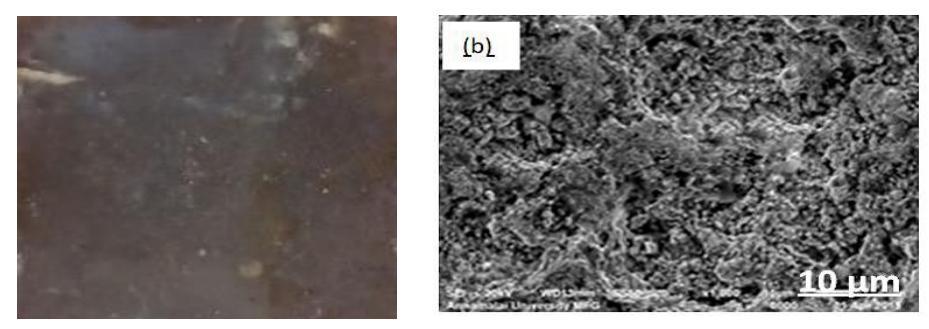
Figure 11(b). Coated AZ91D Mg alloy pH value = 7 Corrosion time= 48 hours Cl - concentration = 0.2 M

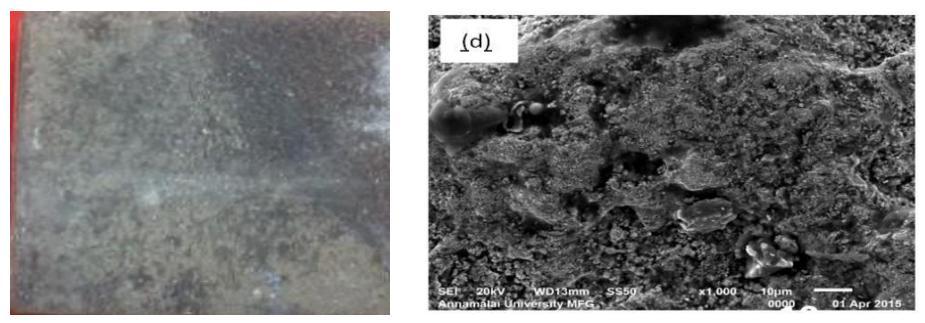
deeper in higher concentration. Even the depth of the pit increases as the solution concentration increases, as displayed in fig. 11(c). Figure 11(d) represents that micro galvanic attack leads the microscale level pits over the coating surface.

Figure 11(d). Coated AZ91D Mg alloy pH value = 7 Corrosion time = 48 hours Cl - concentration = 1 M

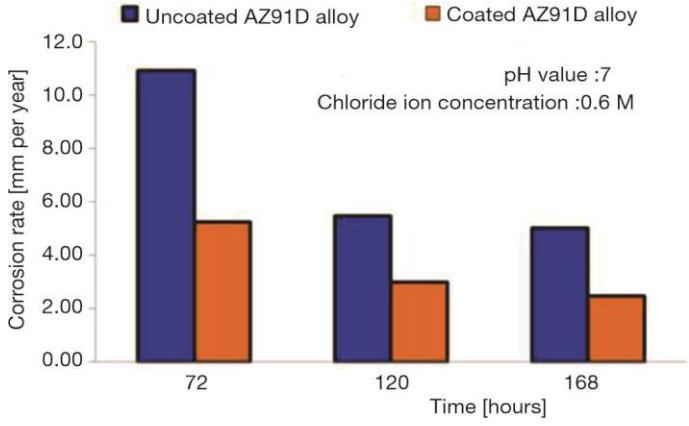
The impact of different exposure times on corrosion rate is denoted in fig. 12. The result was observed the material loss is directly proportional to the exposure time maximum materials loss occurred by high exposure time. The average materials surface

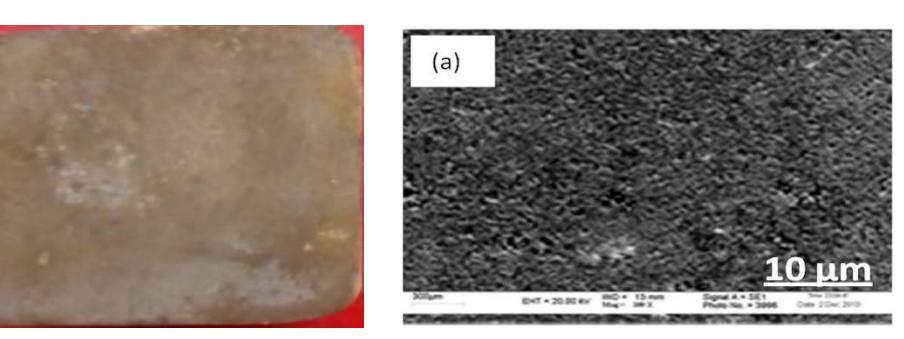
area of the pit is larger, which means that there are few exceptionally large pits in the corroded zone in fig. 13(a) because of extreme localized deep-corrosion attack, carbide phase loss was observed at lower exposure time. Figure 13(b), many cracks occurred on the film surface. A small number of corrosion pits were found on the surface of Mg alloy AZ91D after 168 hours of immersion. In the NaCl solution, the corrosion layer on the surface of the specimen is considerably compacted, thereby effectively preventing further reaction. Consequently, the film's growth rate remains sluggish and creates shallower dimples of corrosion, fig. 13(c). Figure 13(d) represents the coated Mg alloy corroded uniformly due to eliminating the carbide phase from the matrix.

Figure 13(a). Uncoated AZ91D Mg alloy pH value = 7 Corrosion time =36 hours Cl - concentration = 0.6 M

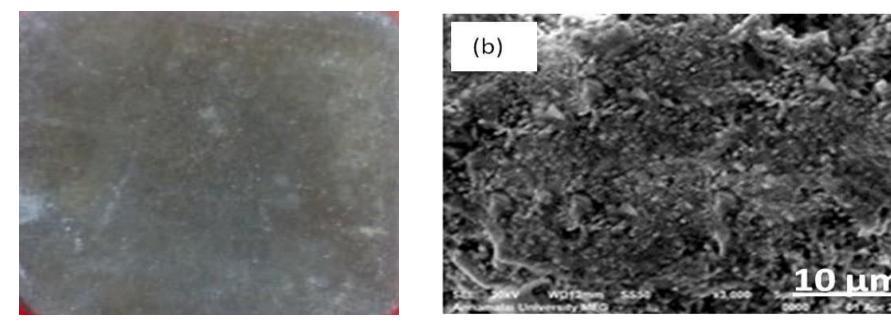
Figure 13(b). Coated AZ91D Mg alloy pH value = 7 Corrosion time = 36 hours Cl - concentration = 0.6 M

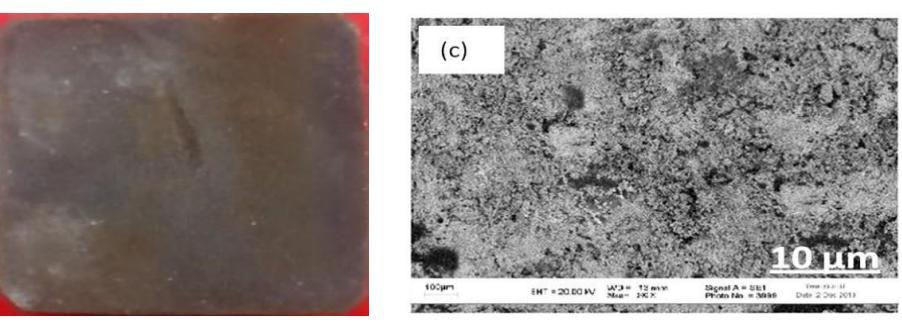
Figure 13(c). Uncoated AZ91D Mg alloy pH value = 7 Corrosion time = 168 hours Cl - concentration = 0.6 M

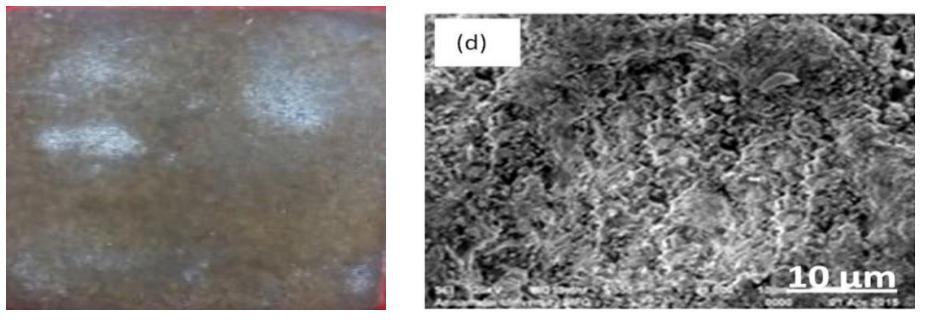
Figure 13(d). Coated AZ91D Mg alloy pH value = 7 Corrosion time = 168 hours Cl - concentration = 0.6 M
