ENERGY REFURBISHMENT OF PUBLIC BUILDINGS UNDER CULTURAL HERITAGE PROTECTION IN SERBIA- CONSTRAINTS AND POTENTIALS

*Milica Đ. JOVANOVIĆ POPOVIĆ, Ljiljana S. ĐUKANOVIĆ, Miloš R. NEDIĆ**

Faculty of architecture, University of Belgrade, Belgrade, Serbia

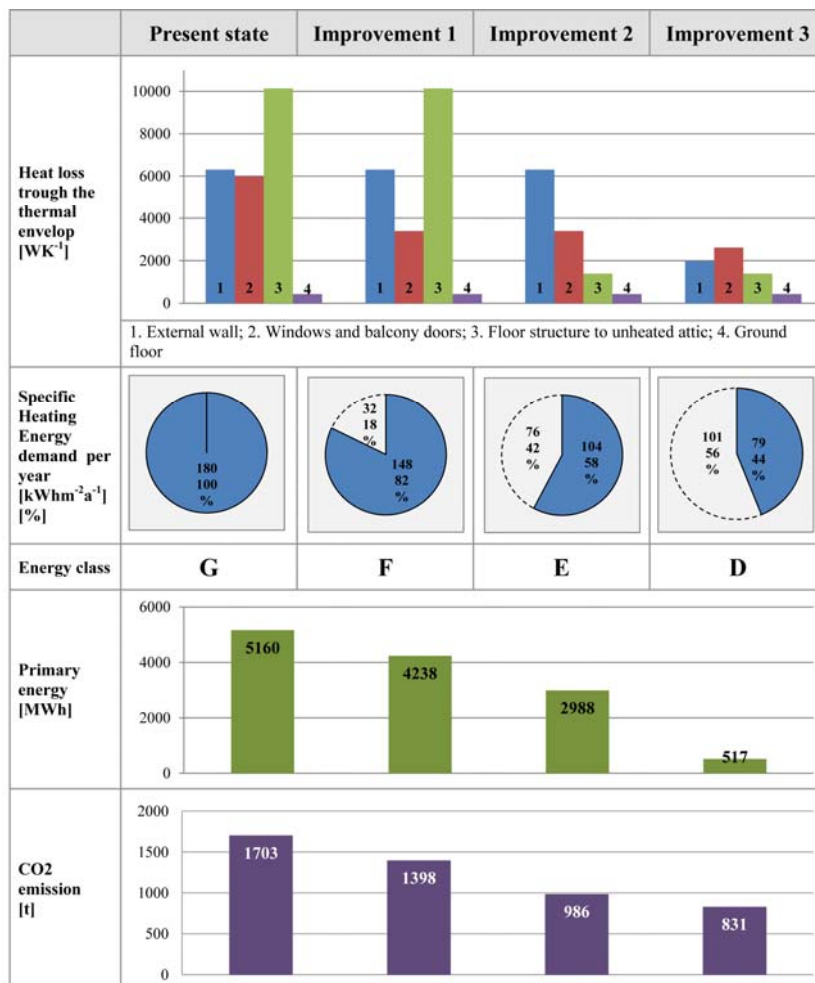
Table 3. National Assembly - energy balance

The first level of improvement covered the glazed parts of the facade envelope showing poor thermal features and air-tightness on a thermographic imaging, all leading to increased ventilation losses. In regard to the aforesaid, instead of the wooden, double frame, double sash windows, proposed were the single frame wooden windows with double-glazed, low-E glass unit filled with krypton. Manufacturing of such windows would require thoroughness and precision in capturing the authentic moulding, division and proportion of individual parts against the whole, in order not to tamper with the original design. The first proposed intervention has upgraded the building from "G" to "F" energy class, accompanied by reduction in the total heating energy demand by 18% annually compared to the baseline situation. Obtained results are shown in tab. 3.

Second level of improvement represents an upgrade to interventions proposed in the previous step. Besides replacing the façade doors and windows, the proposed energy refurbishment encompassed the floor structure towards the unheated attic space, demonstrating the highest energy losses by far. It was constructed as a 20 cm thick reinforced concrete slab with the finishing layer made of cement screed. Thermal insulation of this item represents the least possible investment, while showing best results in terms of reducing the overall heating energy demand. The advantages of intervening on this item are seen in the facilitated access to the attic (without potential obstruction of the building operation during the works), simple works' execution, same as in the fact that this would not in any way affect the overall appearance of the building. The proposed intervention implies insulating the floor structure with 15 cm thick stone wool on the attic side, with the cement screed installed over it in order to enable the unhindered use of the space. This level of improvement considerably contributed to reduced heating energy consumption in comparison with the baseline situation (42%), which was sufficient to upgrade the energy class (from "F" to "E" energy class). Obtained results are shown in tab. 3.

The third level of improvement includes proposed energy refurbishment architectural and civil engineering measures contributing to a maximum increase in the building's energy efficiency, aiming to reach the energy class "C". Wooden windows of the exquisite thermal characteristics were installed, with triple-glazed, low-E glass unit filled with krypton. In addition, aiming to achieve a higher energy class, interventions were proposed on all facade walls not being part of the representative space and not having the luxurious interior finishing, but only rendered and painted surfaces. Any intervention on a building from the past could raise the question of authenticity and this especially refers to the buildings that are recognized by law as protected monuments. In such cases, preservation of the historic value of the facade might be one of the priorities of any intervention on the building [9]. Thermal insulation was also installed on the interior side to preserve the authentic look of the building, by applying the 10 cm thick stone wool, with plasterboard being installed over it. Taking into consideration large wall surfaces covered by this intervention, heating energy demand was

significantly reduced, as follows: by 56% compared to the baseline situation, with the building being upgraded only to energy class "D". Obtained results are shown in tab. 3.

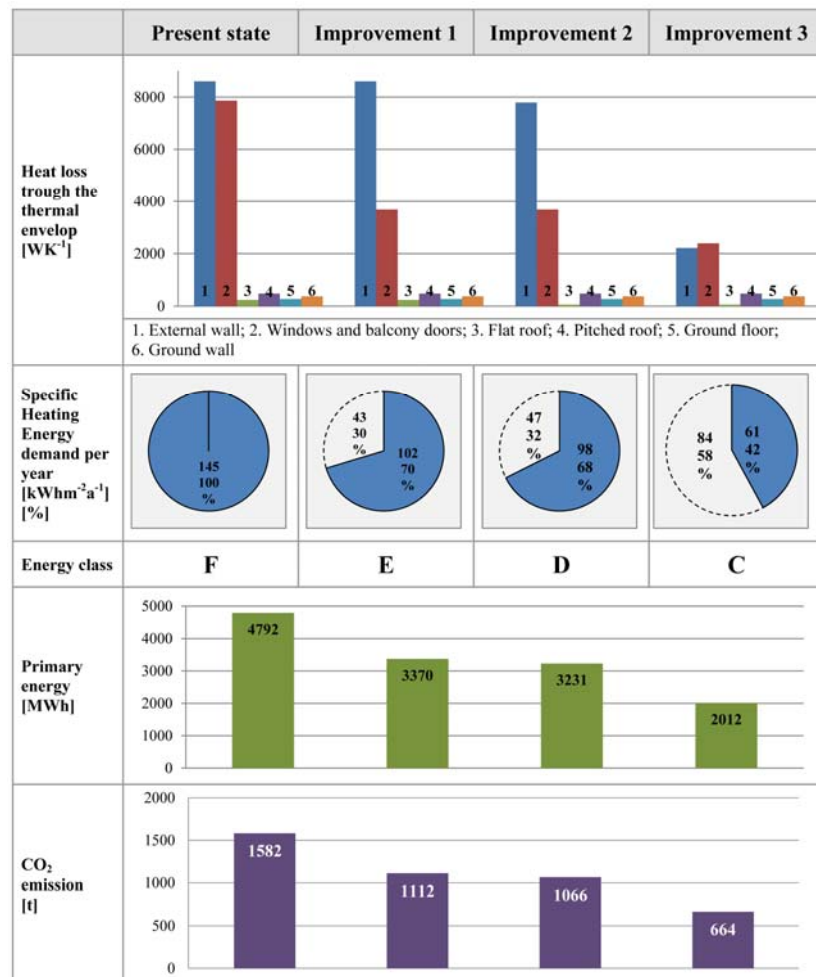
Table 4. Building of the Serbian Government - energy balance

The first level of improvement is focused solely on the glazed parts of the facade envelope, although the facade walls represent the somewhat larger heat loss sources. Such a decision was substantiated by the space users' statements, who have stressed the windows draught issue, confirmed by the expert forensics on the ground. Instead of the wooden double frame, double sash (wide box) windows located on the facade of the oldest part of the building, and wooden, single frame, double-glazed windows in the additionally built part of the annex, wooden double-glazed low-E glass unit

with krypton were proposed. In this was the authenticity of the building was preserved, through application of the wooden frame as in the original design, with the glass performance being significantly improved for this window to meet the current thermal requirements. Roof windows are of a later date. Quality elements of a prominent manufacturer were installed, that are in excellent condition, and thereby they were excluded from the energy refurbishment. This procedure helped improve the energy class "F" to energy class "E", with the reduced energy consumption by 30% compared to the baseline situation. Obtained results are shown in tab. 4.

Second level of improvement is an upgrade to interventions performed in the previous step. Namely, besides replacing the windows, which was taken over from the first improvement level, the energy refurbishment was focused on the annex space (not visible from the street), having neither the stylistic plastics, nor artificial stone on its façade. This enabled interventions on the external part of the structures. The annex walls were insulated with the 15 cm thick stone wool, with facade rendering finishing. Additionally, the interventions included the flat roof above the top annex floor, presently insulated with the 5 cm thick thermal insulation. In scope of this level of improvement, the existing bituminous hydro-insulation of the flat roof was upgraded by the 20 cm stone wool thermal insulation, and new synthetic hydro-insulation membrane (EPDM). This level of improvement slightly contributed to reduced energy consumption in comparison to the previous intervention (only 2%). However this was sufficient to improve the energy class (from "E" to "D" class). The proposed energy refurbishment was focused on the single segment of the building, i.e. the annex, which is spatially separated from the street exposed corpses, thus affecting improvements in the energy performance in this part of the building only, while the remaining spaces were included in the next step. Obtained results are shown in tab. 4.

The third level of improvement includes proposed energy refurbishment architectural and civil engineering measures further contributing to additional increase in the building's energy efficiency, aiming to reach the energy class "C". Wooden windows of the exquisite thermal properties were installed, with triple-glazed, low-E glass unit filled with krypton. Besides this, interventions were undertaken on all facade walls of the street exposed corpses, which were insulated on the interior side in order to preserve the authenticity, lavish the facade plastics and the protected status of the building as the culture monument. Stone wool 10 cm thick was applied, with the plasterboard covering. Having in mind large wall surfaces covered by this intervention, heating energy consumption was significantly reduced (by 58% against the baseline), thereby shifting the building to energy class "C". Obtained results are shown in tab. 4.

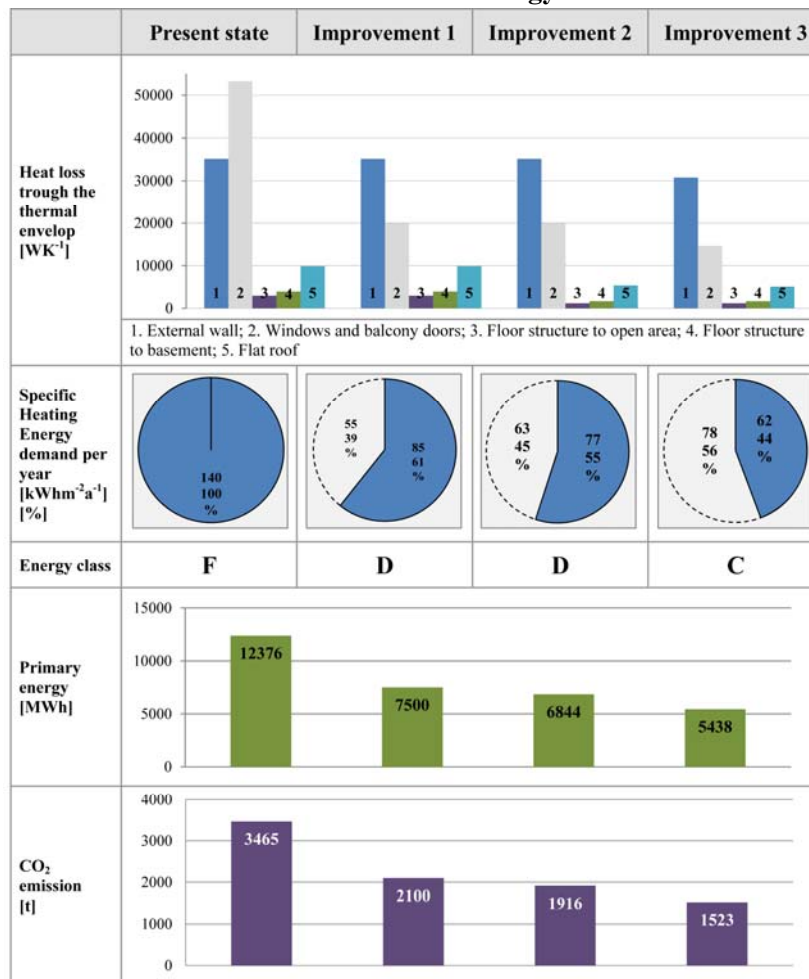
Table 5. The Palace of Serbia - energy balance

The first level of improvement is focused on the glazed parts of the facade envelope representing the major heat loss sources. Replacement of the existing windows and façade doors would not jeopardize the protected building status, with the overall energy performance being significantly improved. In this respect, installation of new aluminum windows and doors with thermal breaks was proposed, with double-glazed, low-E glass unit filled with krypton. In this way, heat losses in the segment of windows and doors were reduced by 50%, with the building being upgraded from "F" to "D" energy class, accompanied by the reduction in the total heating energy demand by 39% annually compared to the baseline situation.

Energy refurbishment of the transparent parts of the building did not take into account the glass lanterns and the dome in the central part of the building. Their glazing with the thermal insulation glass packages could additionally contribute to further reduction in the heating energy demand. However, this intervention would require dismantling the inner interior finishing of

exceptional artistic value, of primary concern for the overall appearance of the building. Obtained results are shown in tab. 5.

The second level of improvement, in addition to the windows' replacement, encompassed the floor structures, bordering external or internal non-heated areas. Flat roofs were insulated by removing the final coverings (gravel and concrete tiles), with the 15 cm stone wool covered with a new synthetic hydro-insulation membrane (EPDM). In addition, floor structures above the passages (gangways-pedestrian bridges and a part above the central front corpse) were insulated with the 8 cm stone wool, with the suspended ceilings being installed. Reed ceilings were removed from the ceiling between the basement and ground level. The structure is insulated with 10cm thick stone wool layer, and a new plasterboard ceiling being installed. Although these procedures did not improve the energy class of the building, heating energy demand was reduced by an additional 6% in comparison to the previous improvement level. Obtained results are shown in tab. 5.

The third level of improvement aims for the maximum level of energy efficiency increase, targeting at achieving the energy class "C". Envisaged was the installation of high-performance aluminum windows namely: frames with thermal breaks and low-E glass unit with krypton filling. Floor structures were insulated same as in the previous procedure (Level 2), with additional insulation of suspended ceilings surrounding the lanterns. Moreover, aiming to achieve the higher energy class, facade parapet walls, without a special interior finishing, were insulated, without threatening the protected status of the building. Stone wool 10 cm thick was installed on the interior part of the walls, with the plasterboard covering. In order to avoid damages to the interior wall finishing, a special refurbishment measure was applied reflecting in filling of the hollow spaces in specific facade walls by blowing-in the thermal insulation granules or threads. These measures have raised the building to energy class "C" with achieving energy savings of 56% compared to the baseline situation. Obtained results are shown in tab.5.
